INSPECTION REPORT: KENSINGTON GOLD MINE

Date of Inspection: March 24, 2023
Date of Report: June 21, 2023
USDA Forest Service Inspector: Casey Loofbourrow

Sites visited during the inspection included: Access roads, Comet waste rock storage area, Comet Water Treatment Plant (CWTP), Sherman Creek Outfall 001, Mill Ponds, Pit 4, Fuel Depot, Port Facility, Tailings Treatment Facility (TTF) and access road.

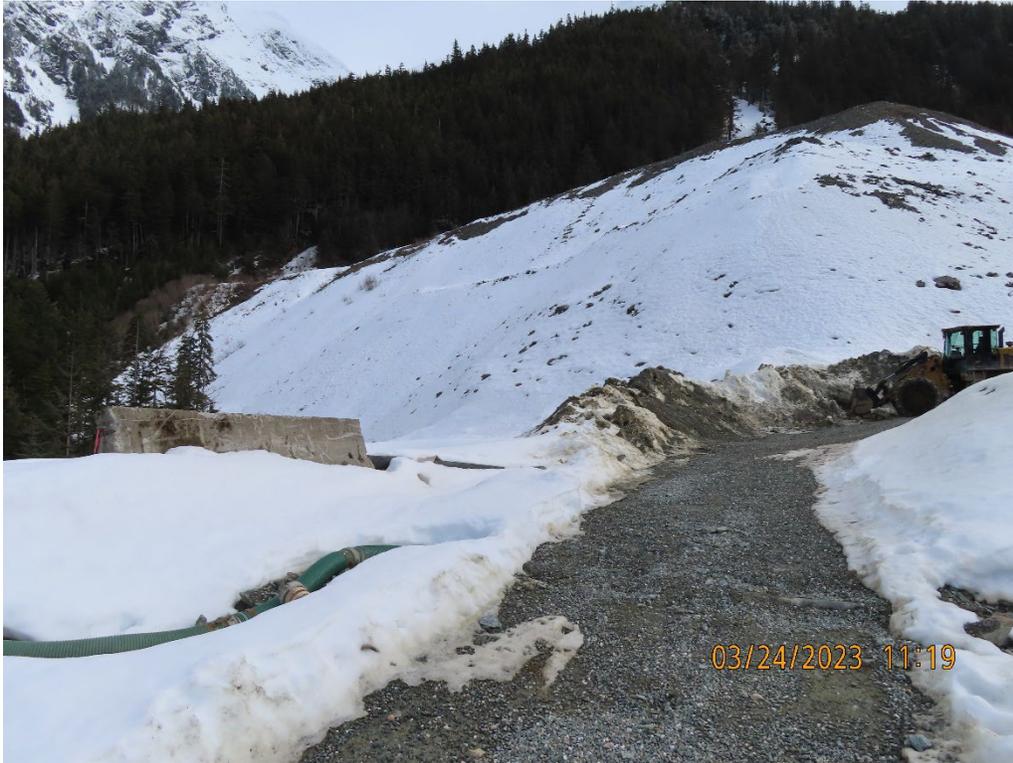
The Comet waste rock storage pile was stable (Photo 1) and there had been no recent waste rock placement at this site.

Photo 1. The Comet development pile.

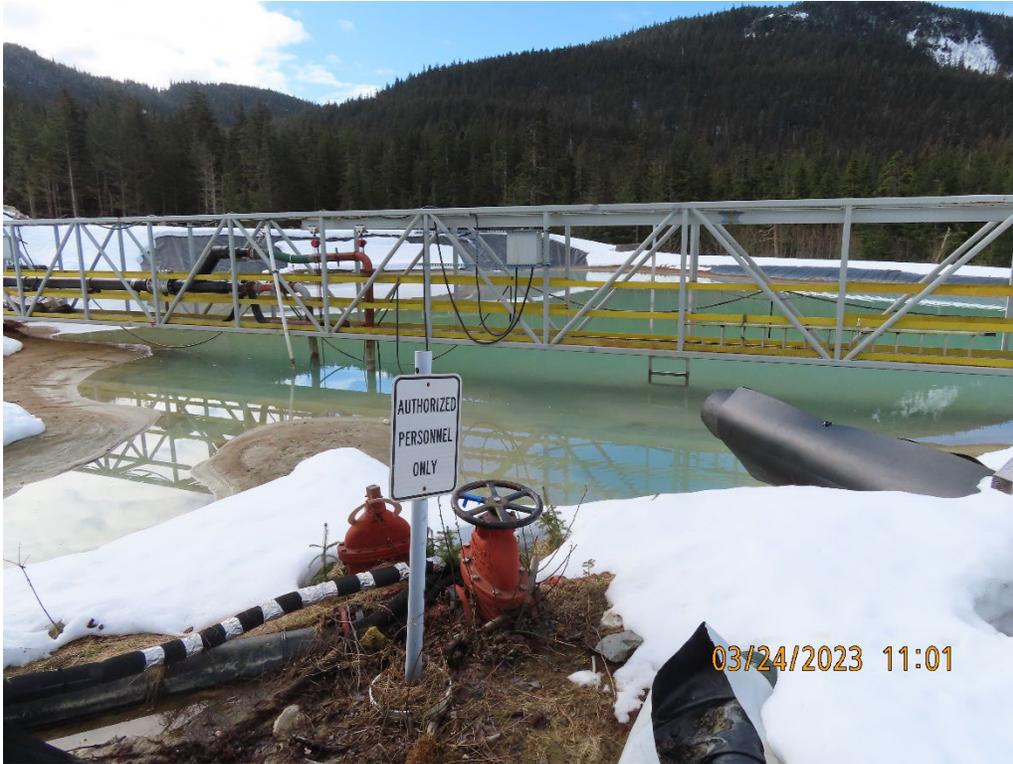
Pond one was not accessible during this inspection. Pond 2 appeared in good condition (Photo 2).

Photo 2. CWTP pond 2.

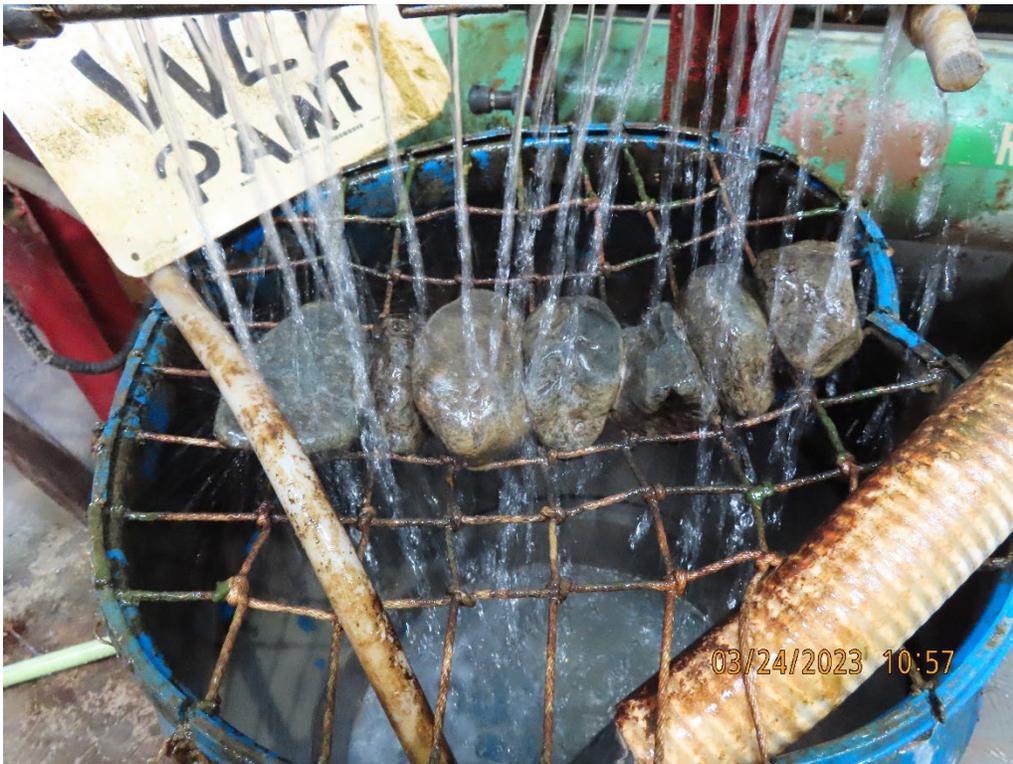
White material was observed on the test rocks used for monitoring in the CWTP (Photo 3).

Photo 3. White material test rocks in the CWTP.

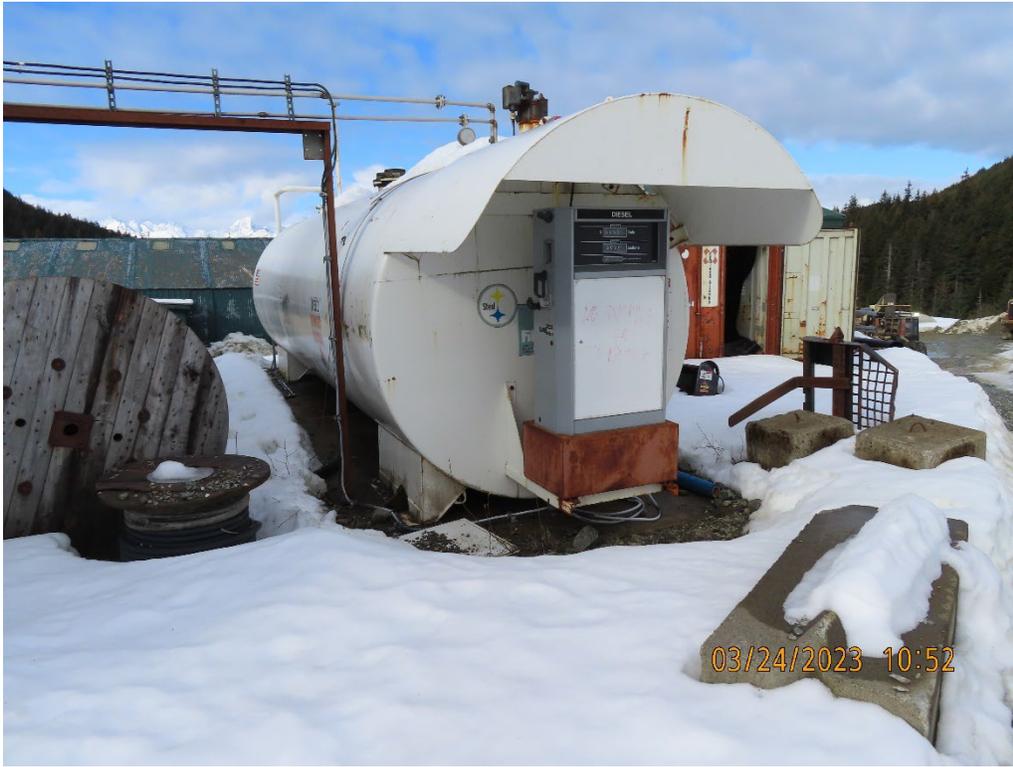
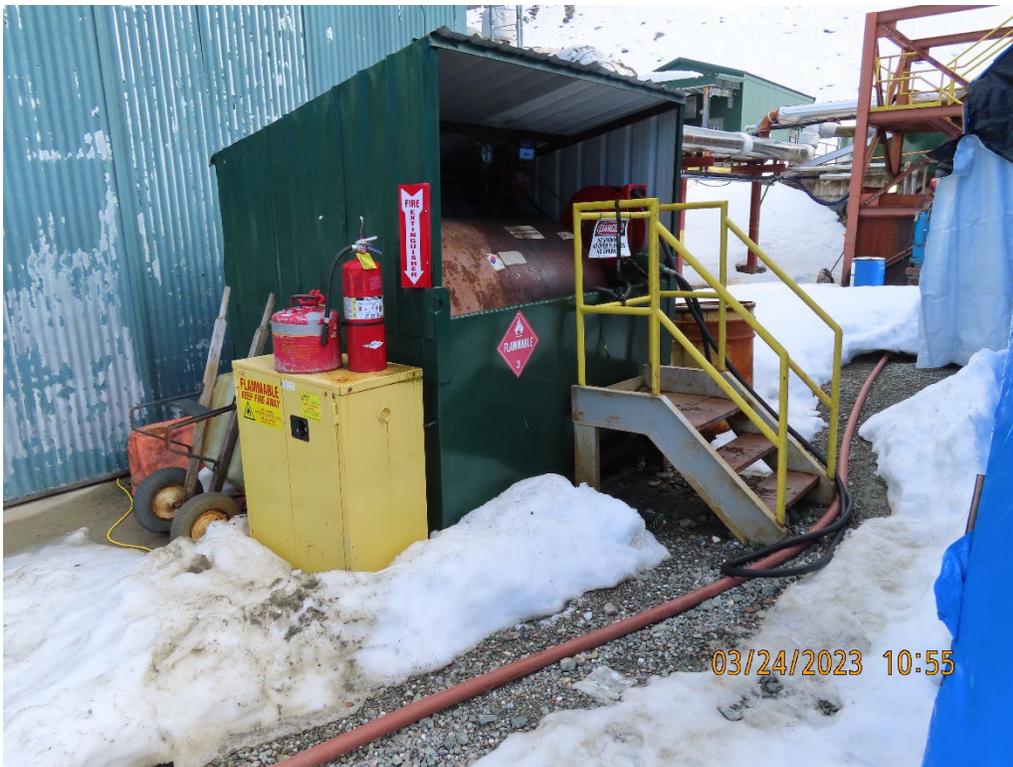
Fuel tanks (Photos 4-5) and spill response materials (Photo 6) were observed and appeared in good condition.

Photo 4. Fuel tank near CWTP.

Photo 5. Fuel tank near CWTP.

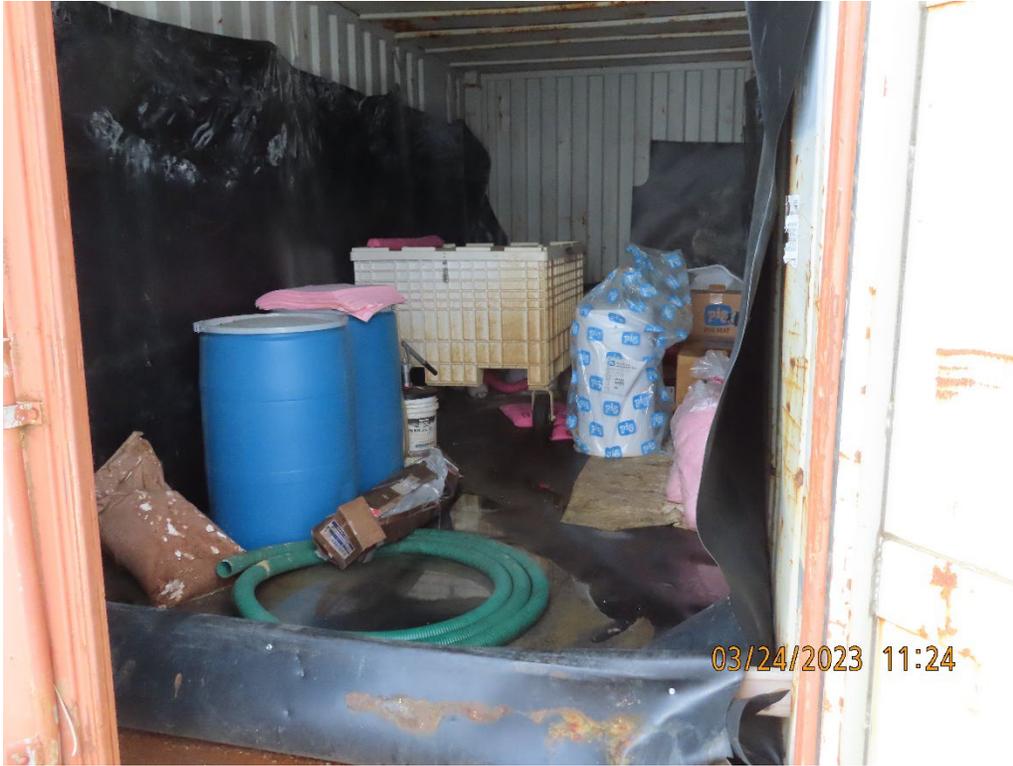
Photo 6. Spill response materials staged at CWTP.

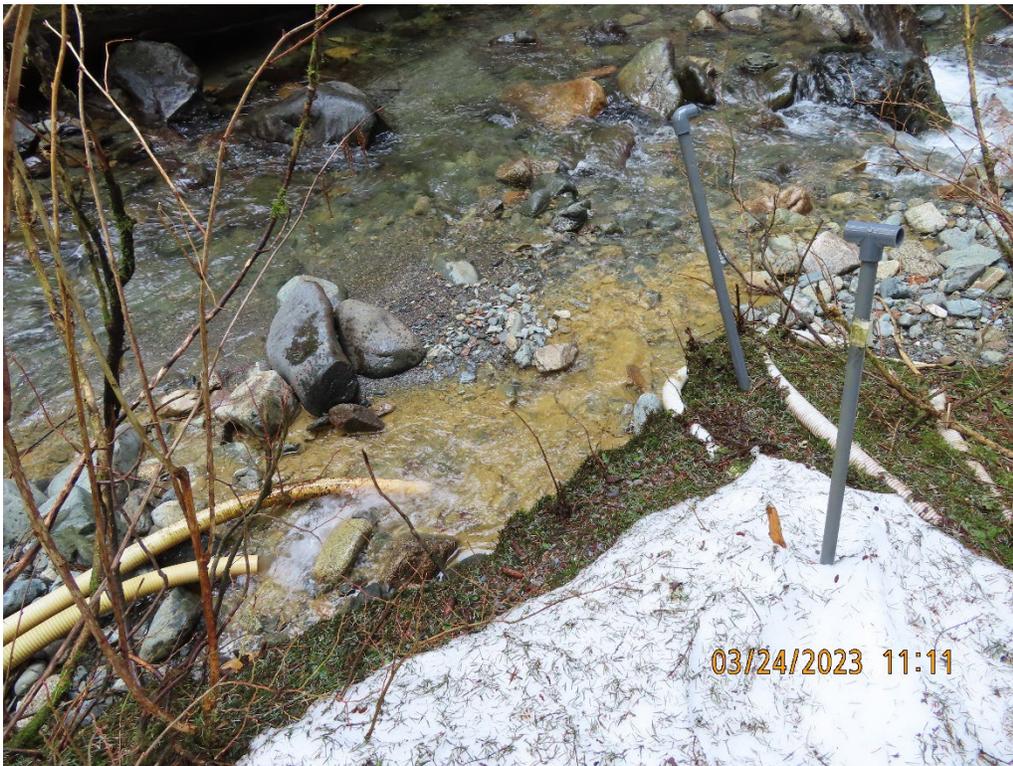
White material was observed at Outfall 001 in Sherman Creek (Photo 7). Coeur Alaska believes colloidal sulfur generated by acidification of sodium thiosulfate following breakpoint chlorination is likely the white material and is evaluating the use of soda ash to prevent its formation.

Photo 7. Sherman Creek Outfall 001 showing white material.

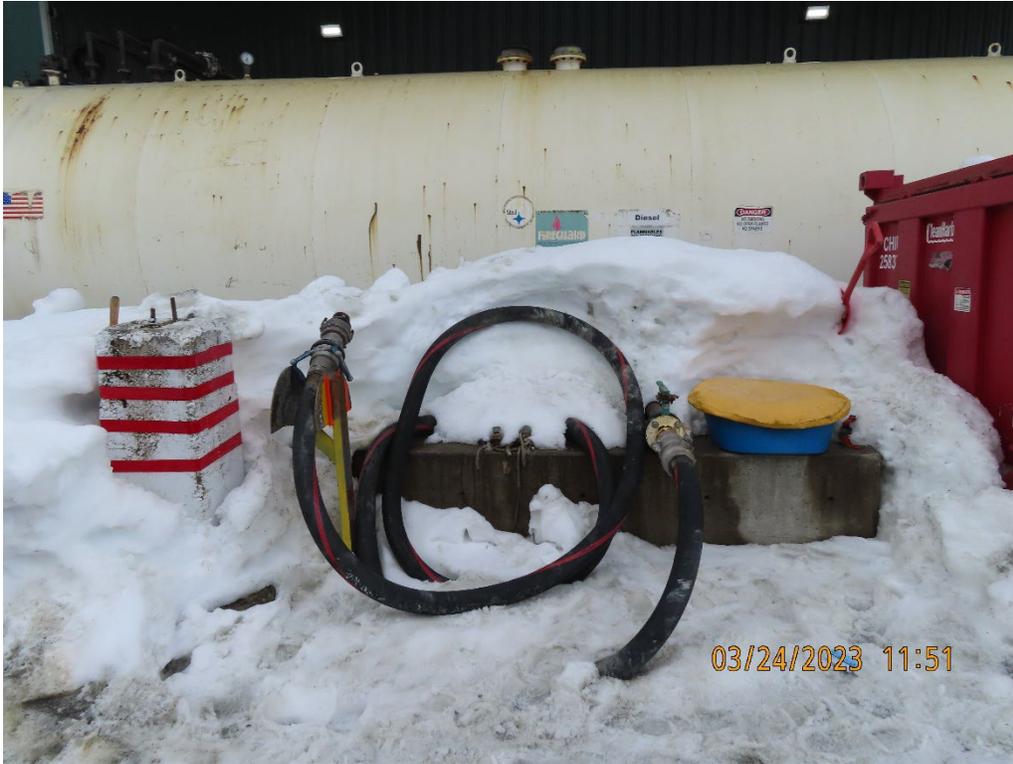
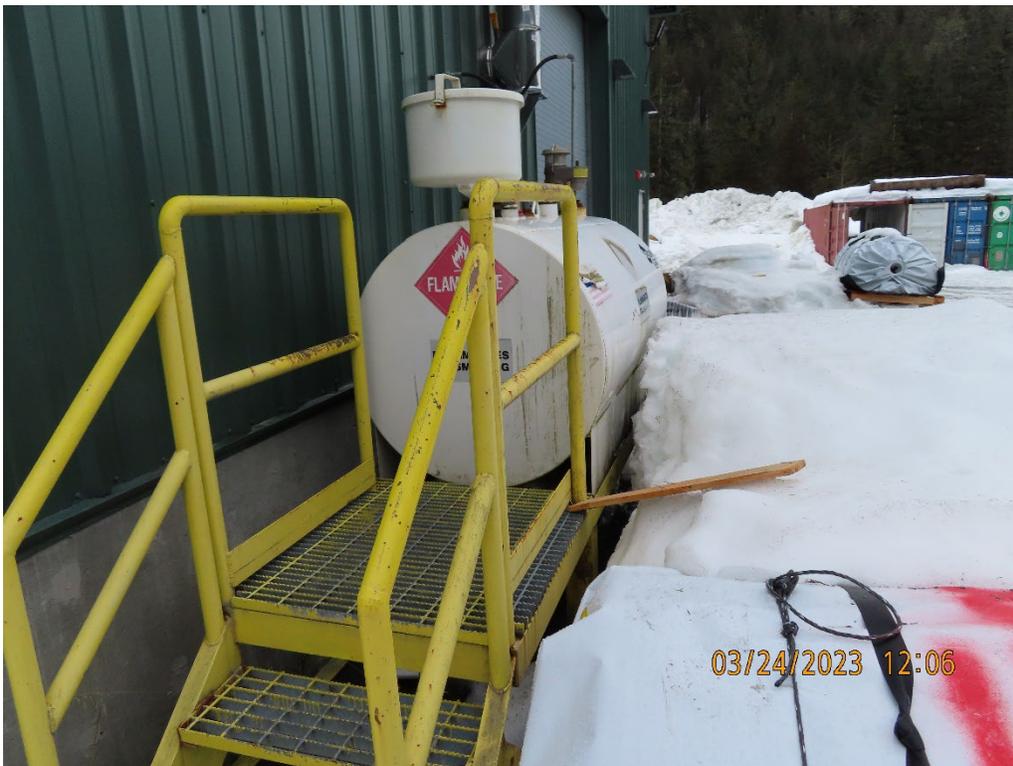
Day tanks for fuel storage (Photos 8-9) at the mill bench and camp area were inspected. No leaks or maintenance issues were observed.

Photo 8. Day tank adjacent to generators.

Photo 9. Fuel tank near warehouse area.

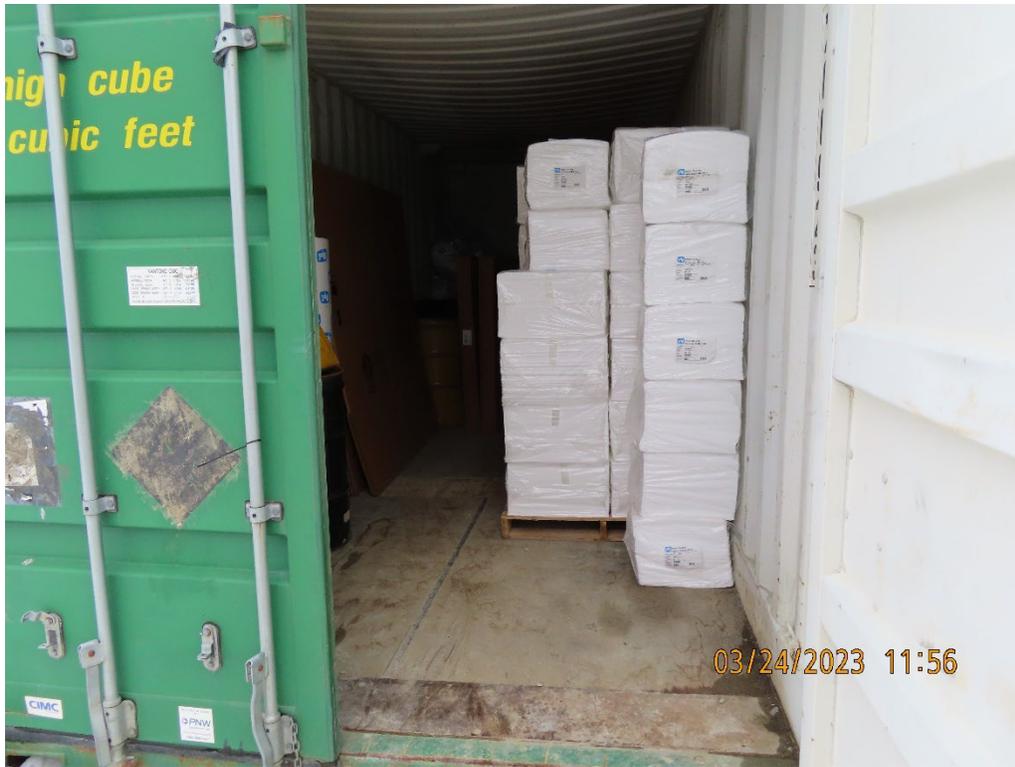
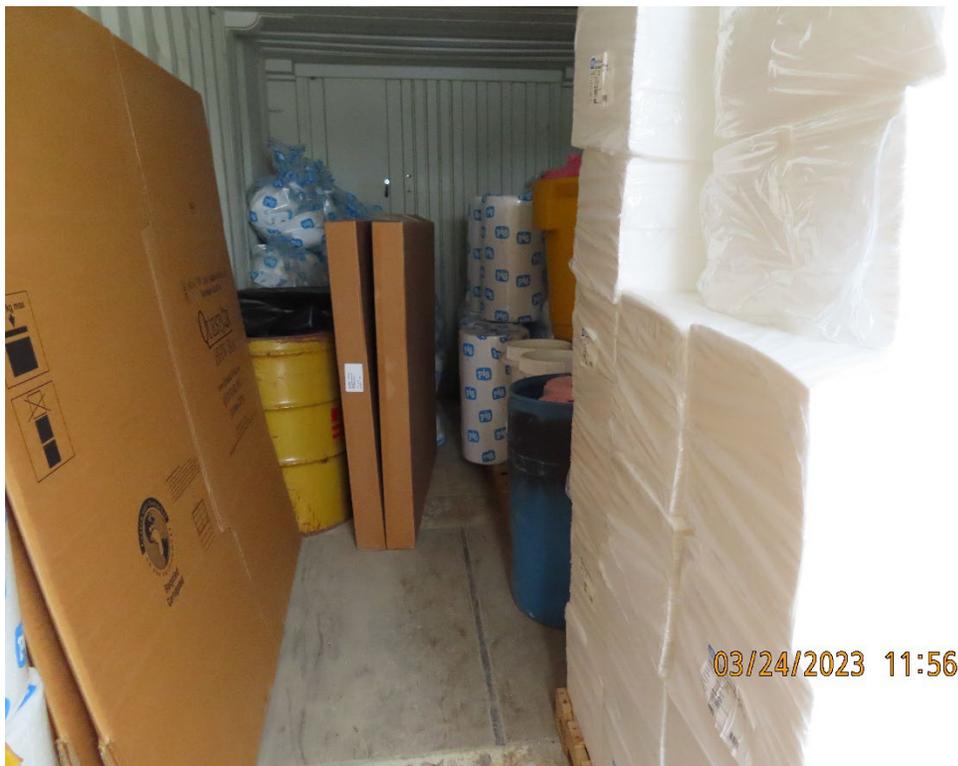
Spill response materials were staged at several locations (Photos 10-11).

Photo 10. Spill response materials near mill bench.

Photo 11. Spill response materials near mill bench.

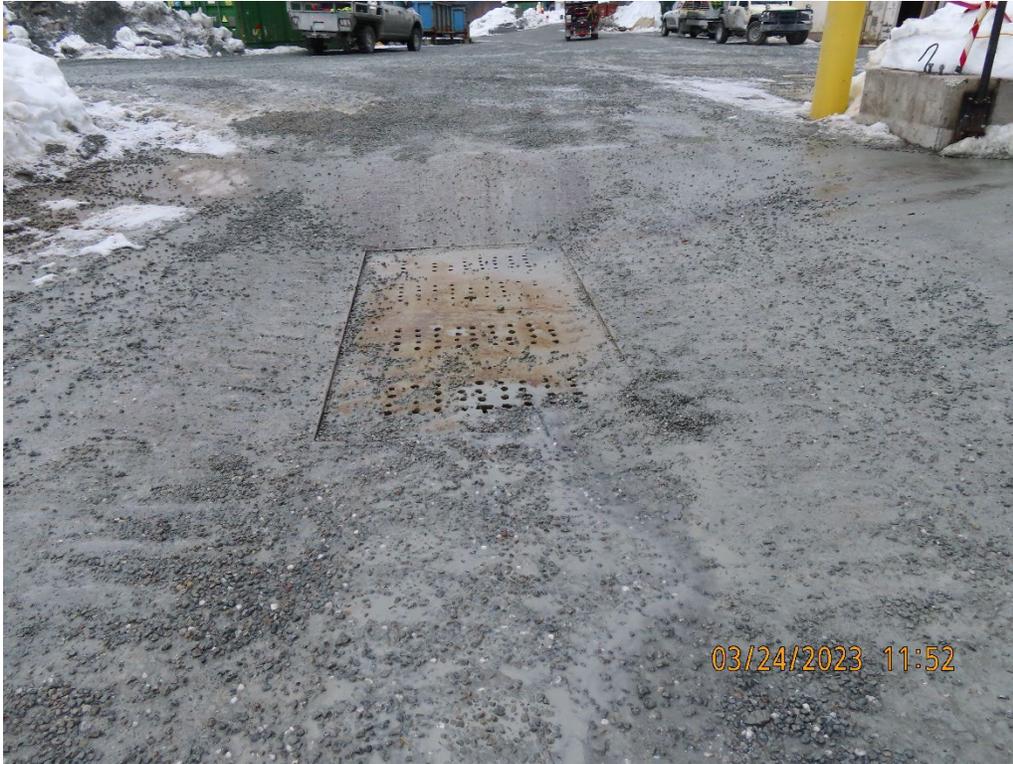
Adjacent to the 30,000 gallon generator fuel tank there is a fuel bay drain (Photo 12) containing an oil water separator which appeared to be functioning as intended and not covered in snow or ice. This

equipment is inspected and maintained as necessary weekly and was inspected the day before this inspection.

Photo 12. Drain leading to oil water separator near generator fuel tank.

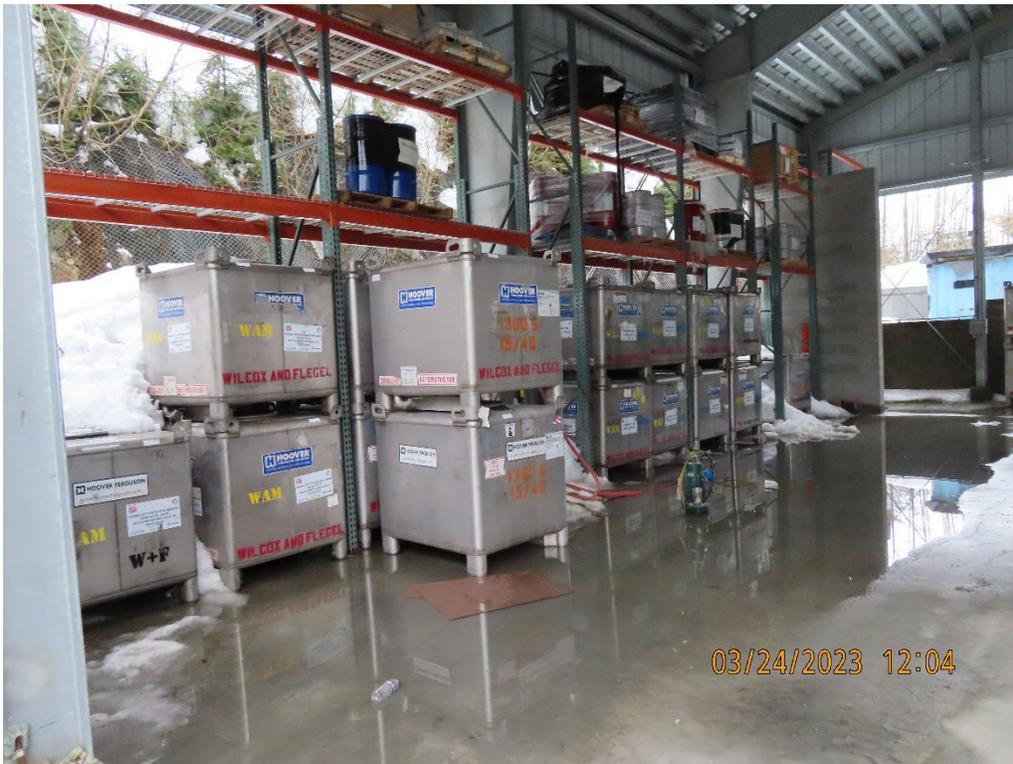
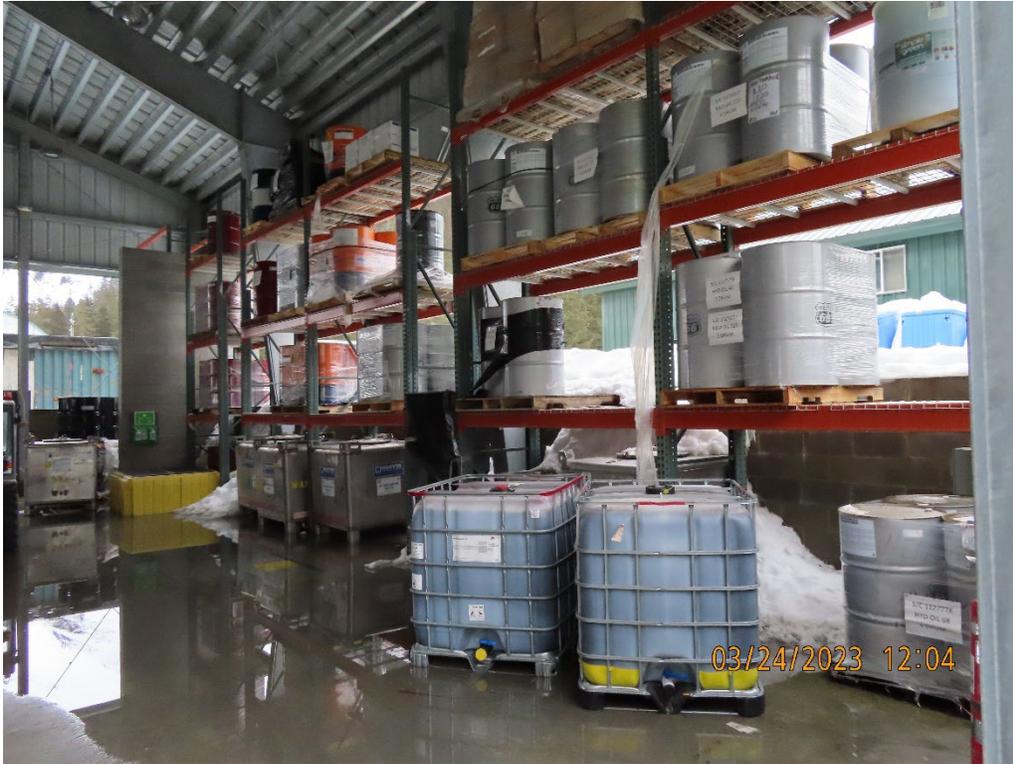
The warehouse containing hazardous materials was orderly (Photos 13-14). Snow contaminated with hydrocarbons was staged at this location (Photo 15) and will be disposed of at an approved facility.

Photo 13. Warehouse interior.

Photo 14. Warehouse interior.

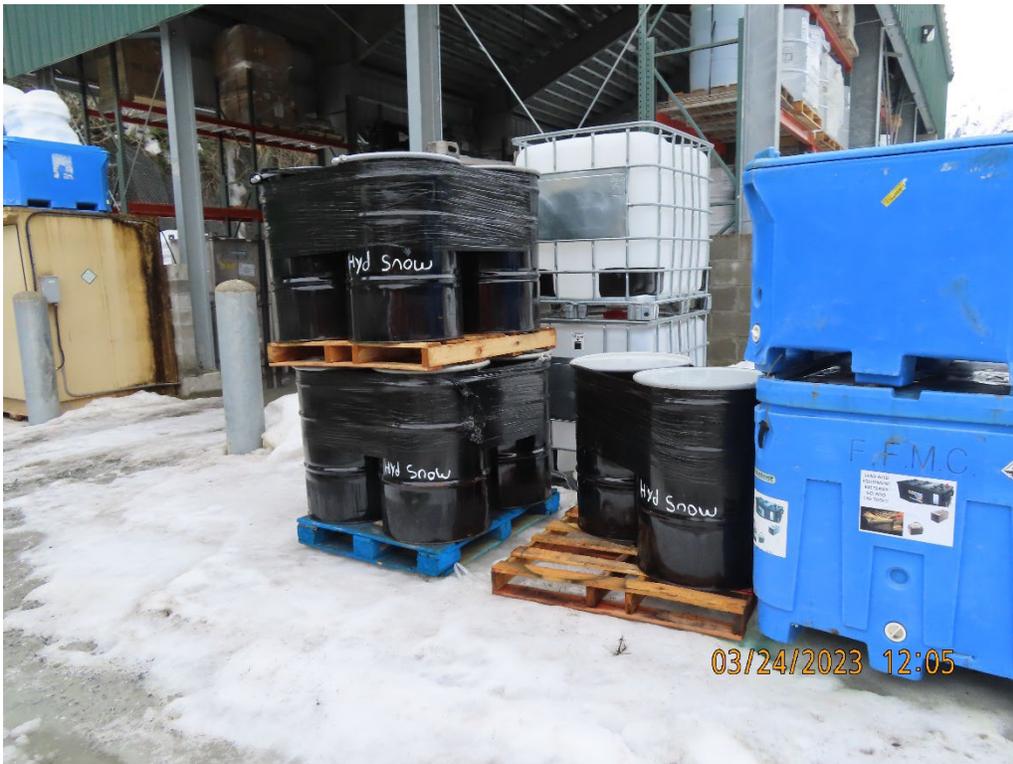
Photo 15. Contaminated material staged for disposal.

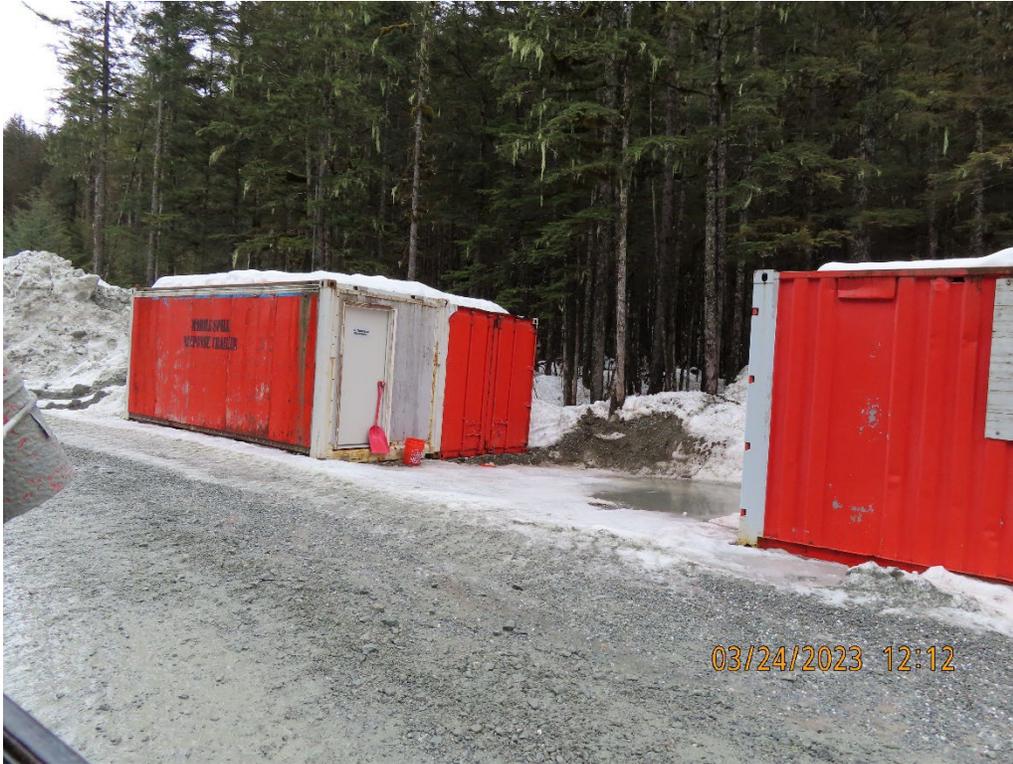
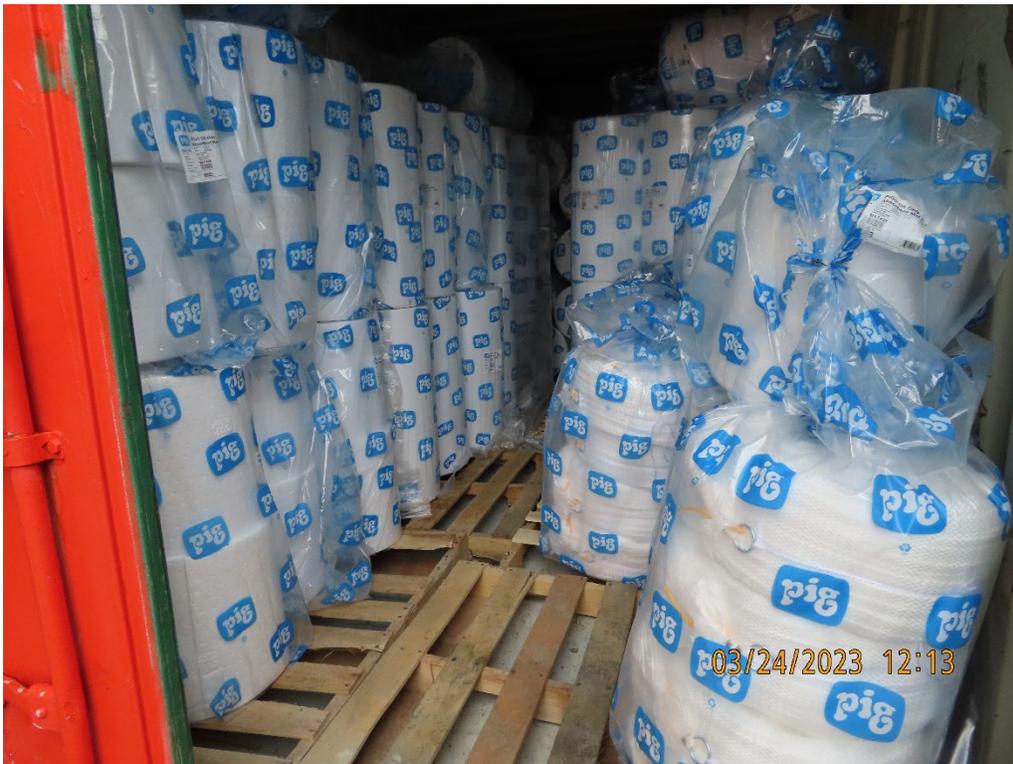
Fuel spill response trailers were located on the access road below the camp (Photos 16-17)

Photo 16. Mobile fuel response trailers.

Photo 17. Inside mobile fuel response trailers.

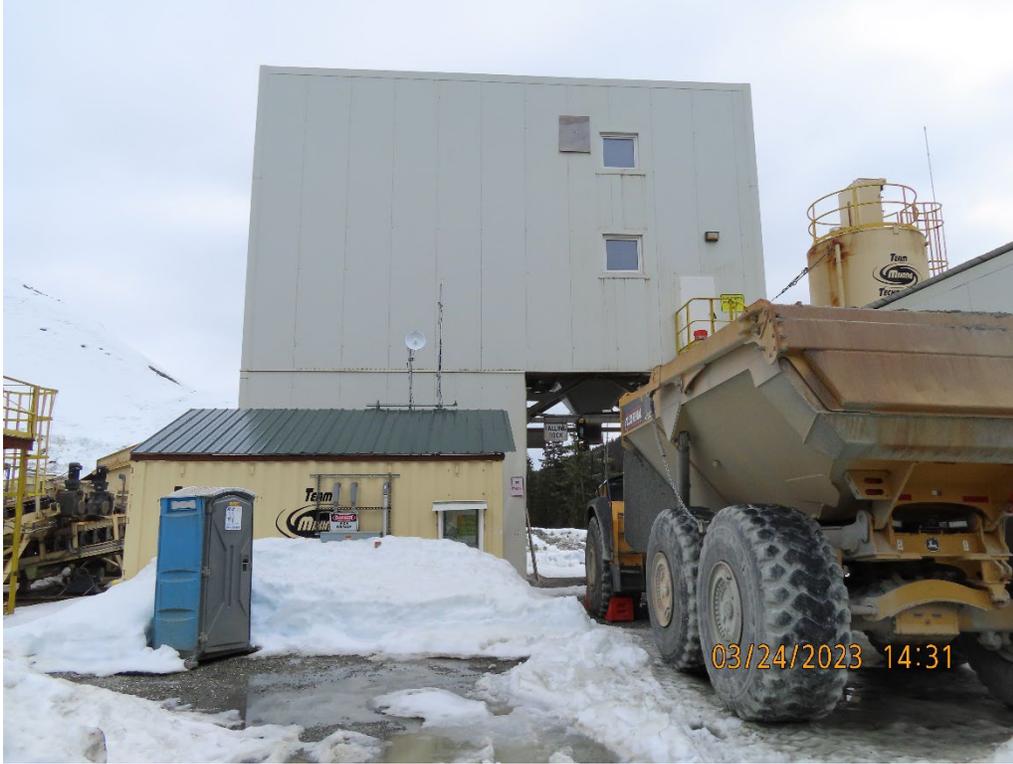
The Pug Plant was currently offline during the winter months (Photo 18).

Photo 18. Pug Plant.

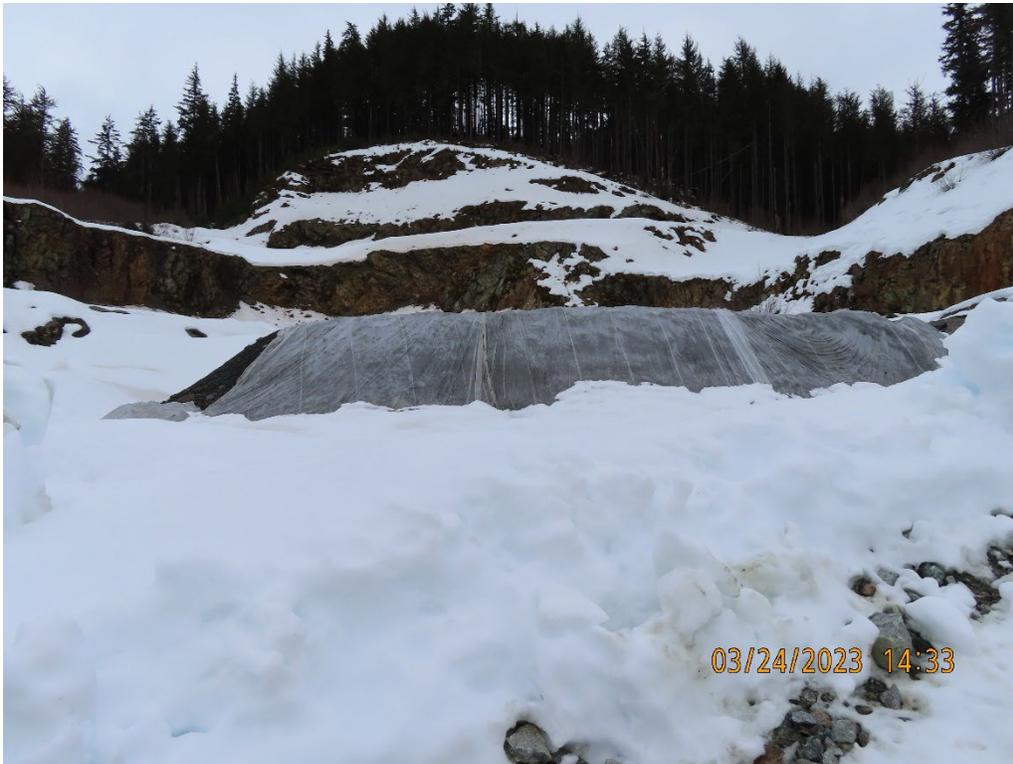
Graphitic phyllite is stockpiled at this location and covered to prevent rainwater infiltration. A small portion of the cover had blown off the stockpile (Photo 19), and Mr. Bailey informed the Forest Service it was covered the next day and provided a photograph (Photo 20).

Photo 19. Graphitic phyllite stockpile partially uncovered.

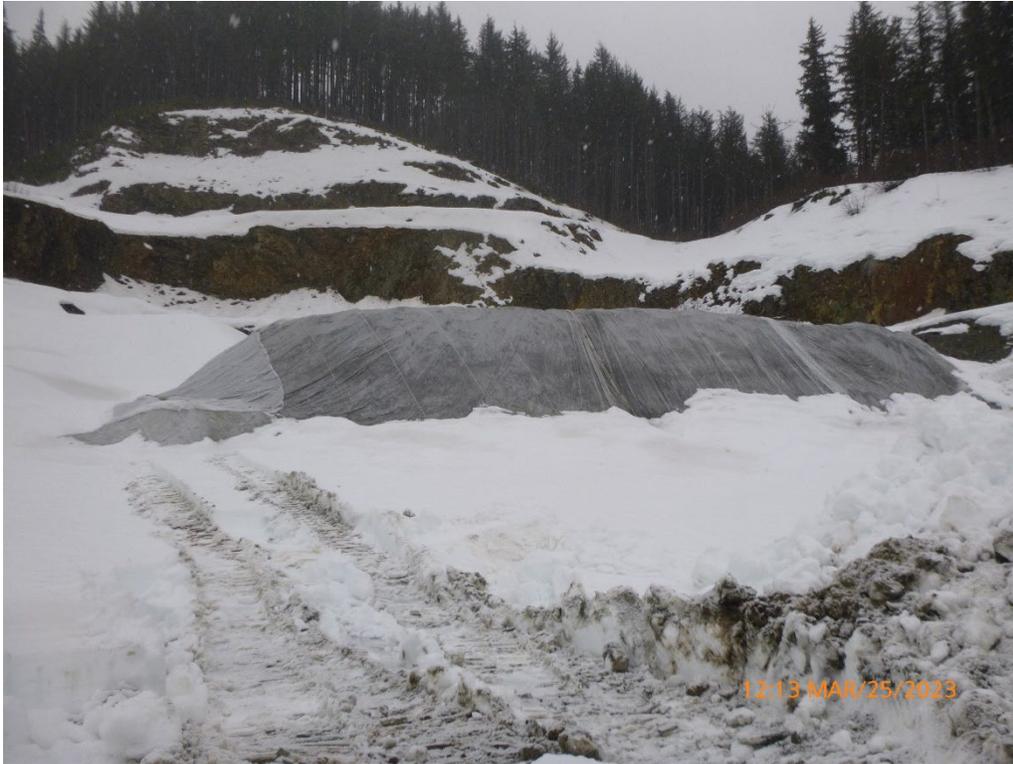
Photo 20. Graphitic phyllite stockpile covered March 25, photo curtesy Coeur Alaska.

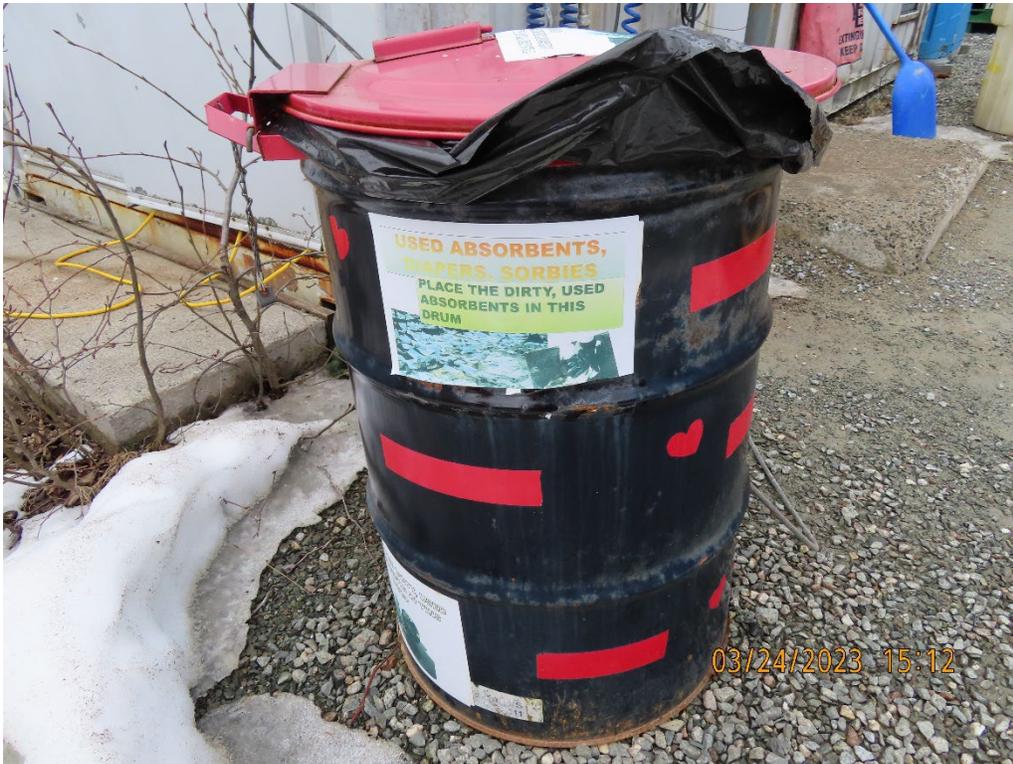
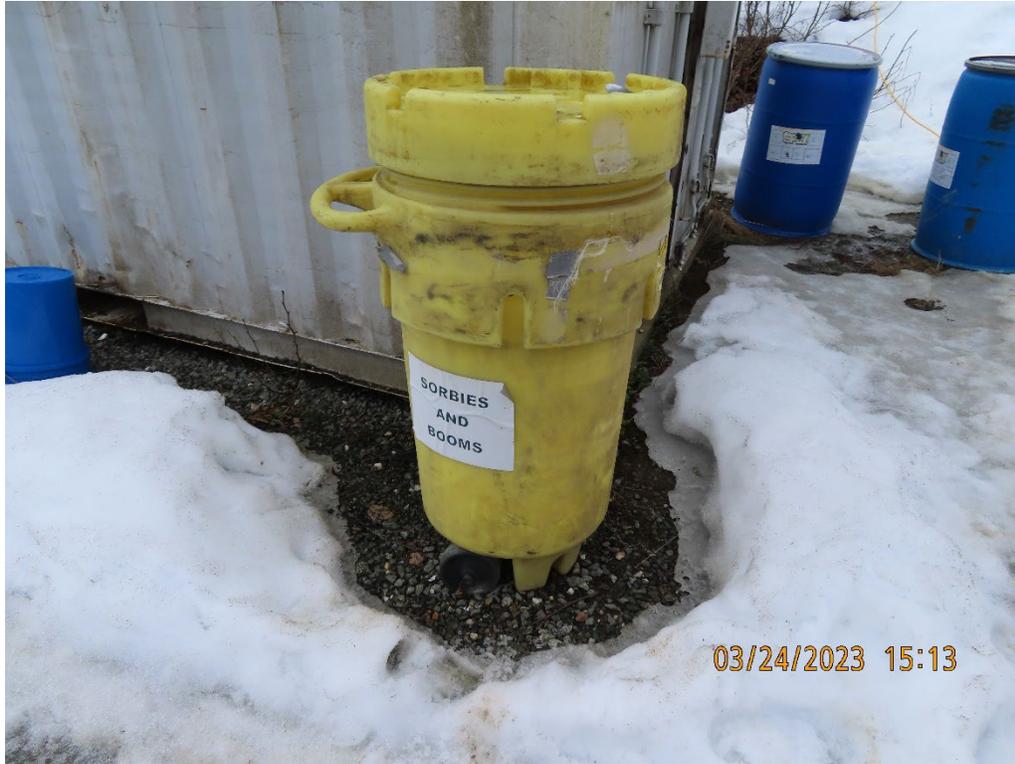
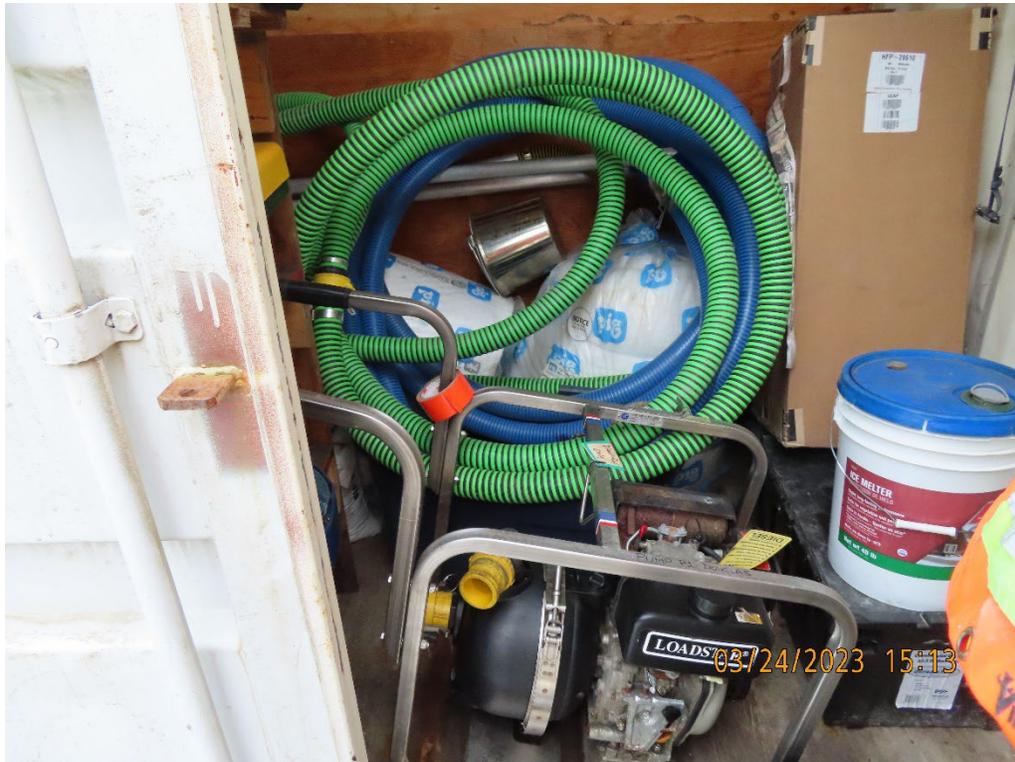
Spill response materials are present at this location (Photos 21-23) and the fuel tank for a mobile heater unit was observed placed in secondary containment (Photo 24).

Photo 21. Container used for contaminated spill response materials at Pit 4.

Photo 22. Spill response materials at Pit 4.

Photo 23. Spill response materials at Pit 4.

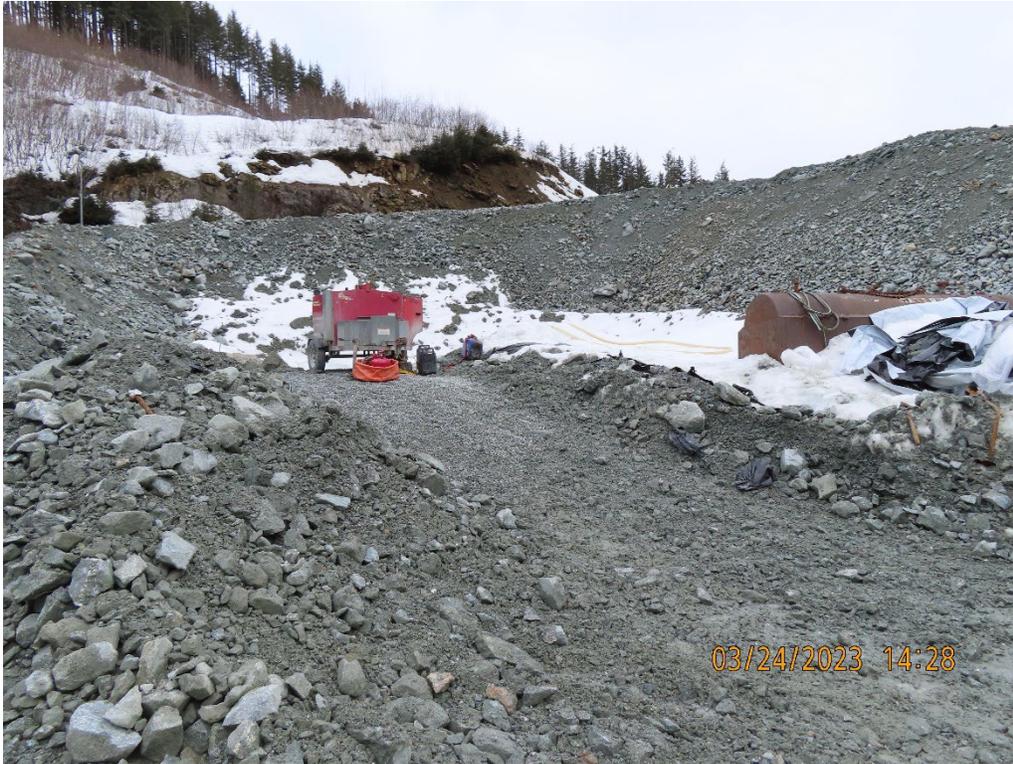
Photo 24. Mobile heater unit, fuel tank in secondary containment.

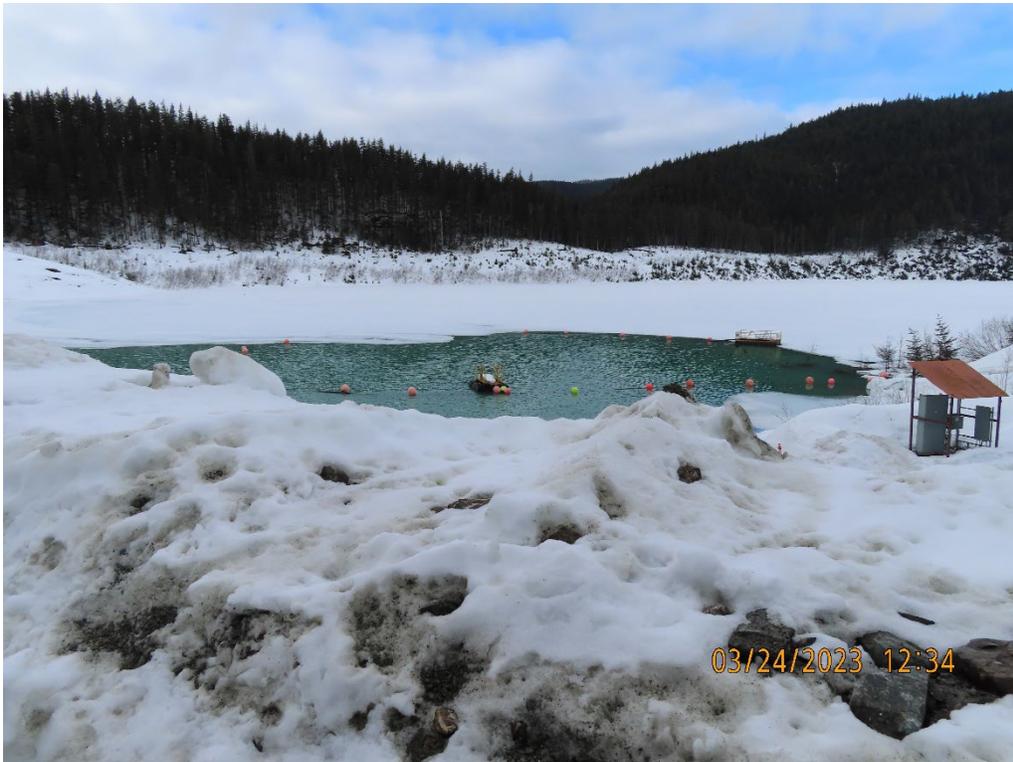
Tailings deposition was occurring near the southeast portion of the TTF (Photo 25).

Photo 25. TTF tailings deposition area.

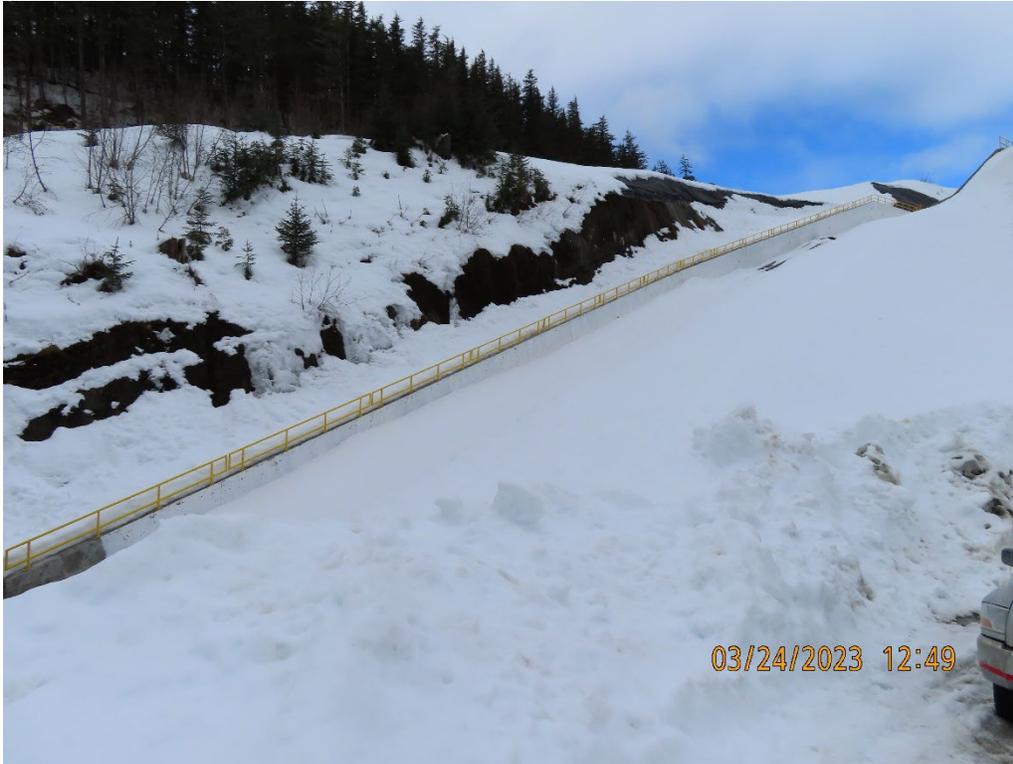
The TTF dam spillway appeared in good condition and was covered with snow and ice. There were no visual signs of ARD seepage in the spillway (Photo 26).

Photo 26. TTF spillway.

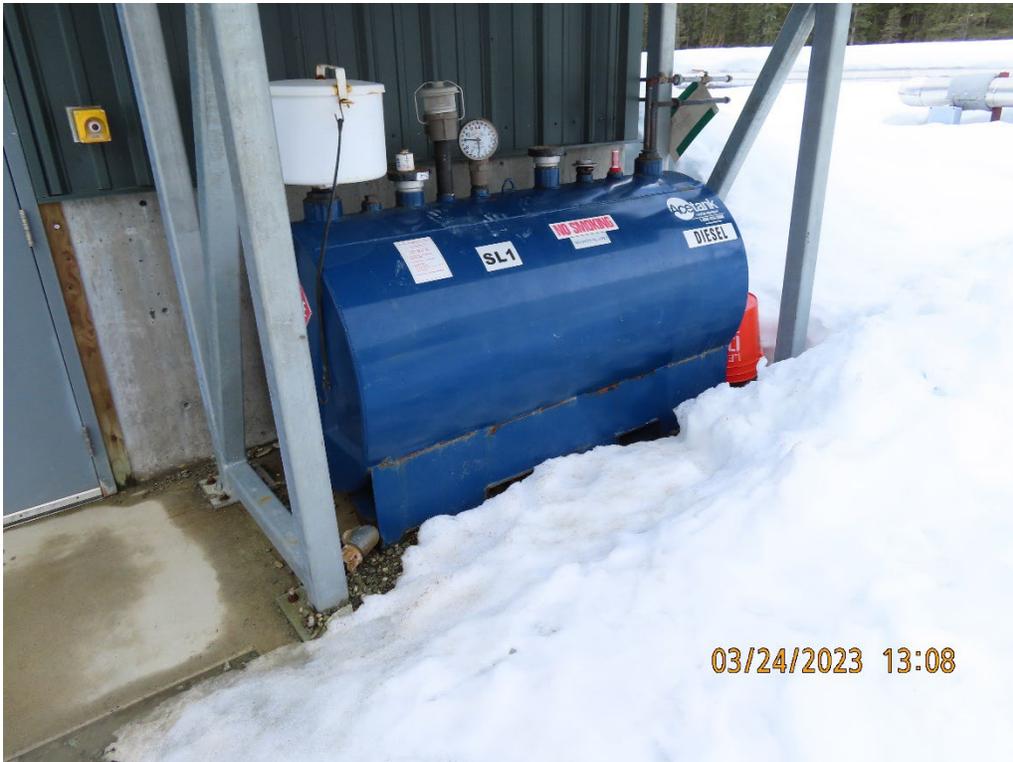
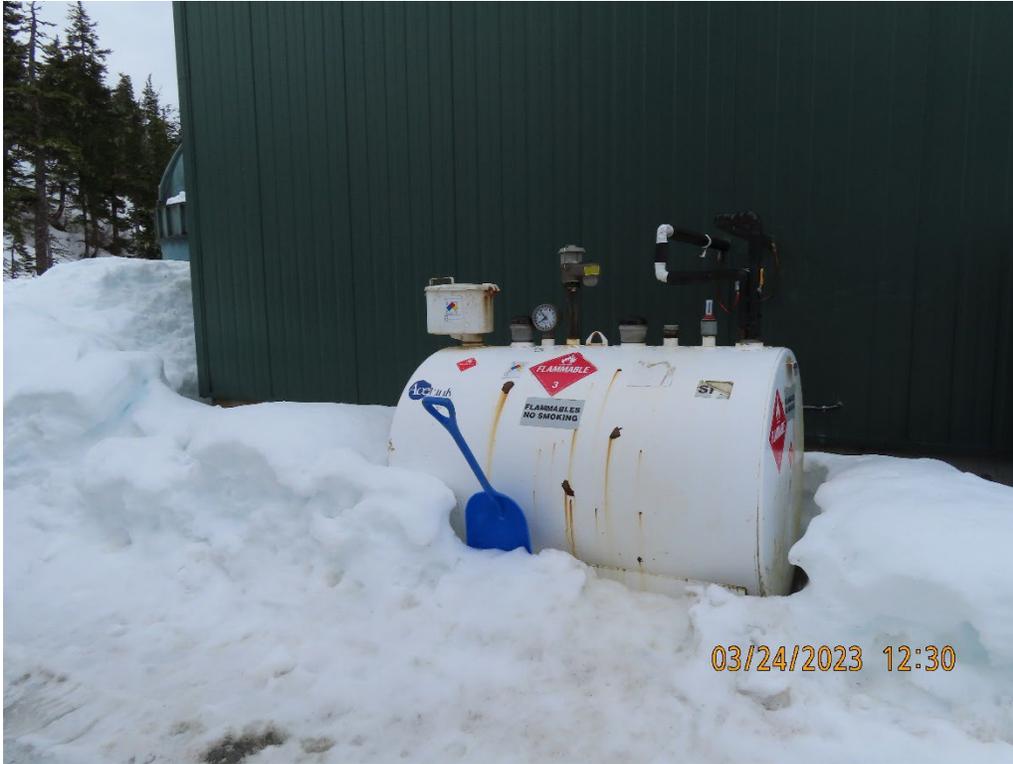
The fuel tanks adjacent to the WTP were in good condition (Photos 27-28).

Photo 27. Fuel tank at TTF WTP.

Photo 28. Fuel tank at TTF WTP.
